Casualty Circular - 01 of 2024

Sub.: Annual Report – 2023 By the DG Communication Centre on the Incidents Reported – reg.

ANNUAL REPORT - 2023
BY THE
DG COMMUNICATION
CENTRE ON THE
INCIDENTS REPORTED

**The Directorate General of Shipping,
Ministry of Ports, Shipping & Waterways,
Government of India.**

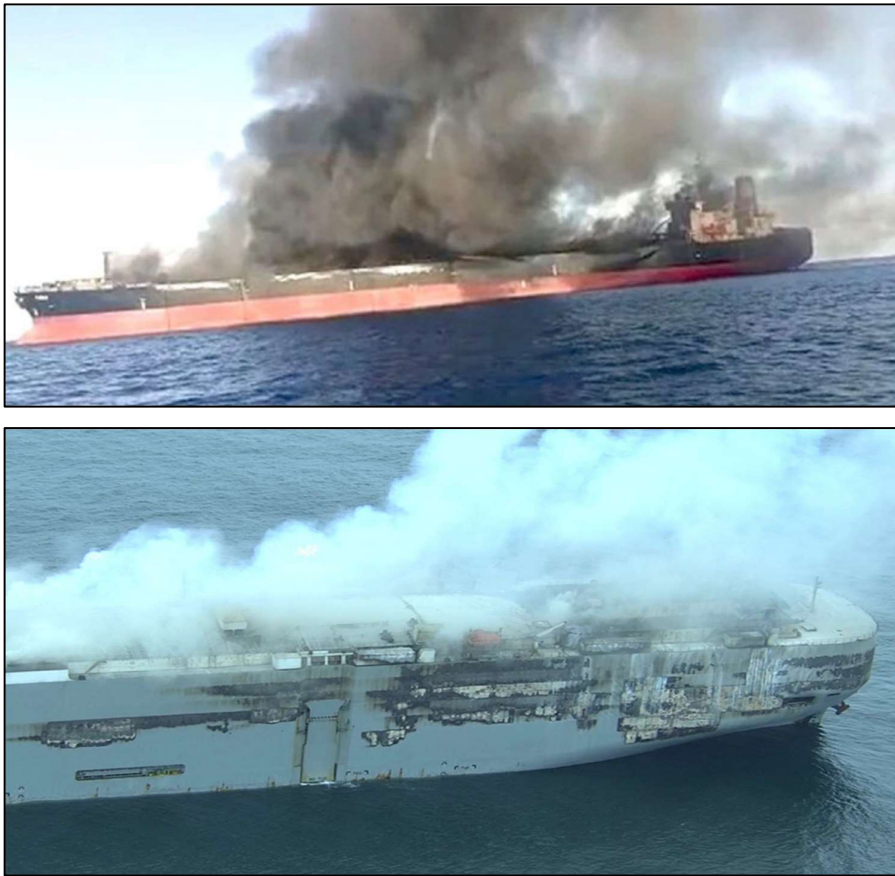
Figure 1: Fire and explosion on tanker in Malaysian waters and fire on a car carrier in North Sea
